1991 TRAFFIC SAFETY IMPROVEMENT STUDY

TRAFFIC SAFETY IMPROVEMENT STUDY

CITY OF GREAT FALLS

MARVIN & ASSOCIATES

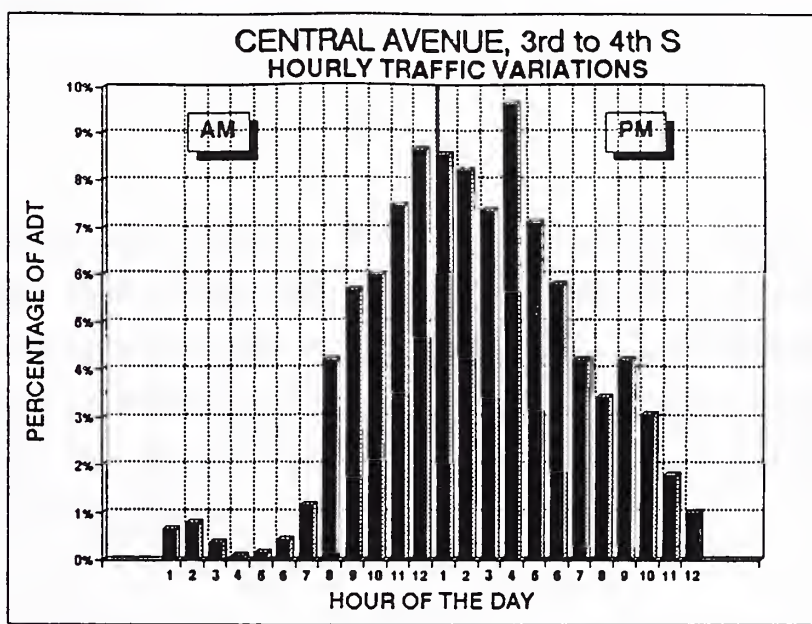
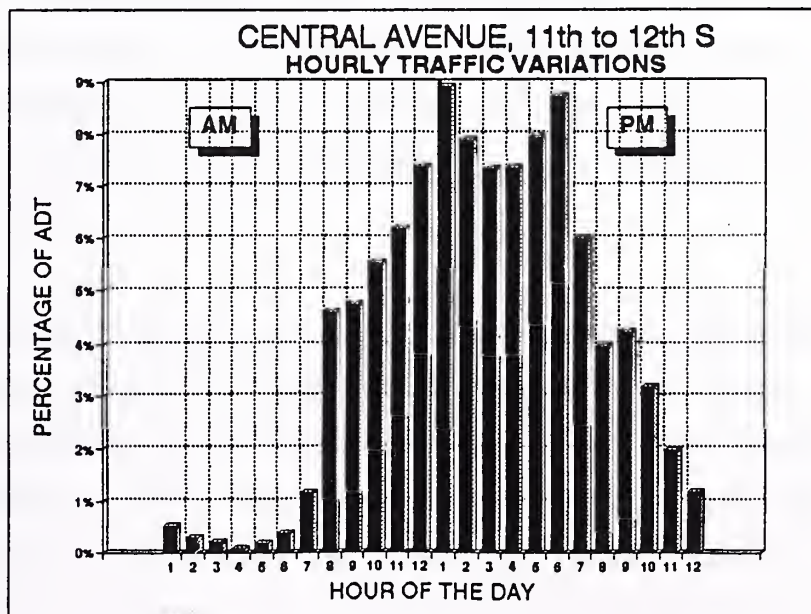
Figure 5., right, presents hourly traffic variations on Central Avenue at two separate locations. These are only two of numerous hourly count summaries prepared from data provided by the City of Great Falls.

Both graphs have the same basic shape, but the CBD count has the highest peak (4-5PM) which would indicate a higher concentration of employment in the CBD than the fringe area. The count between 11th and 12th also has more defined noon and evening peaks as would be expected.

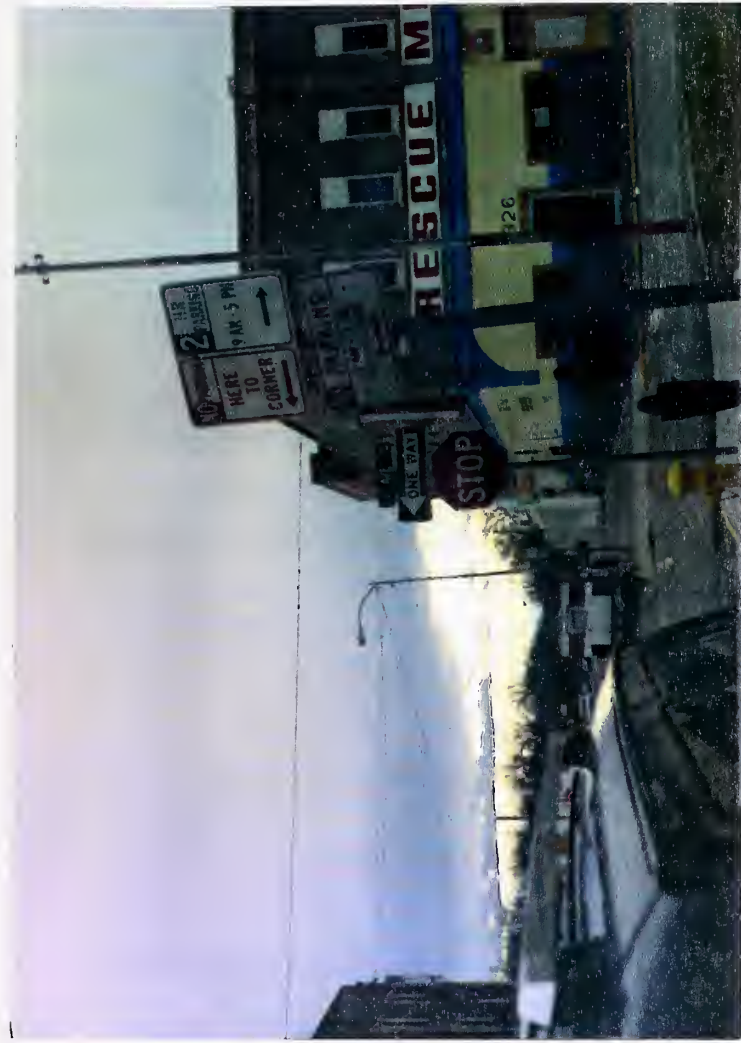
4TH ST. S, SIGNS IN NW CORNER
